CAZAUX-WILLIAMS-CROW HOUSE (HALCYON HALL)

Application for City of Wilmington Local Landmark Designation

Prepared by Samantha Smith, Gate City Preservation, L.L.C.

November 2019

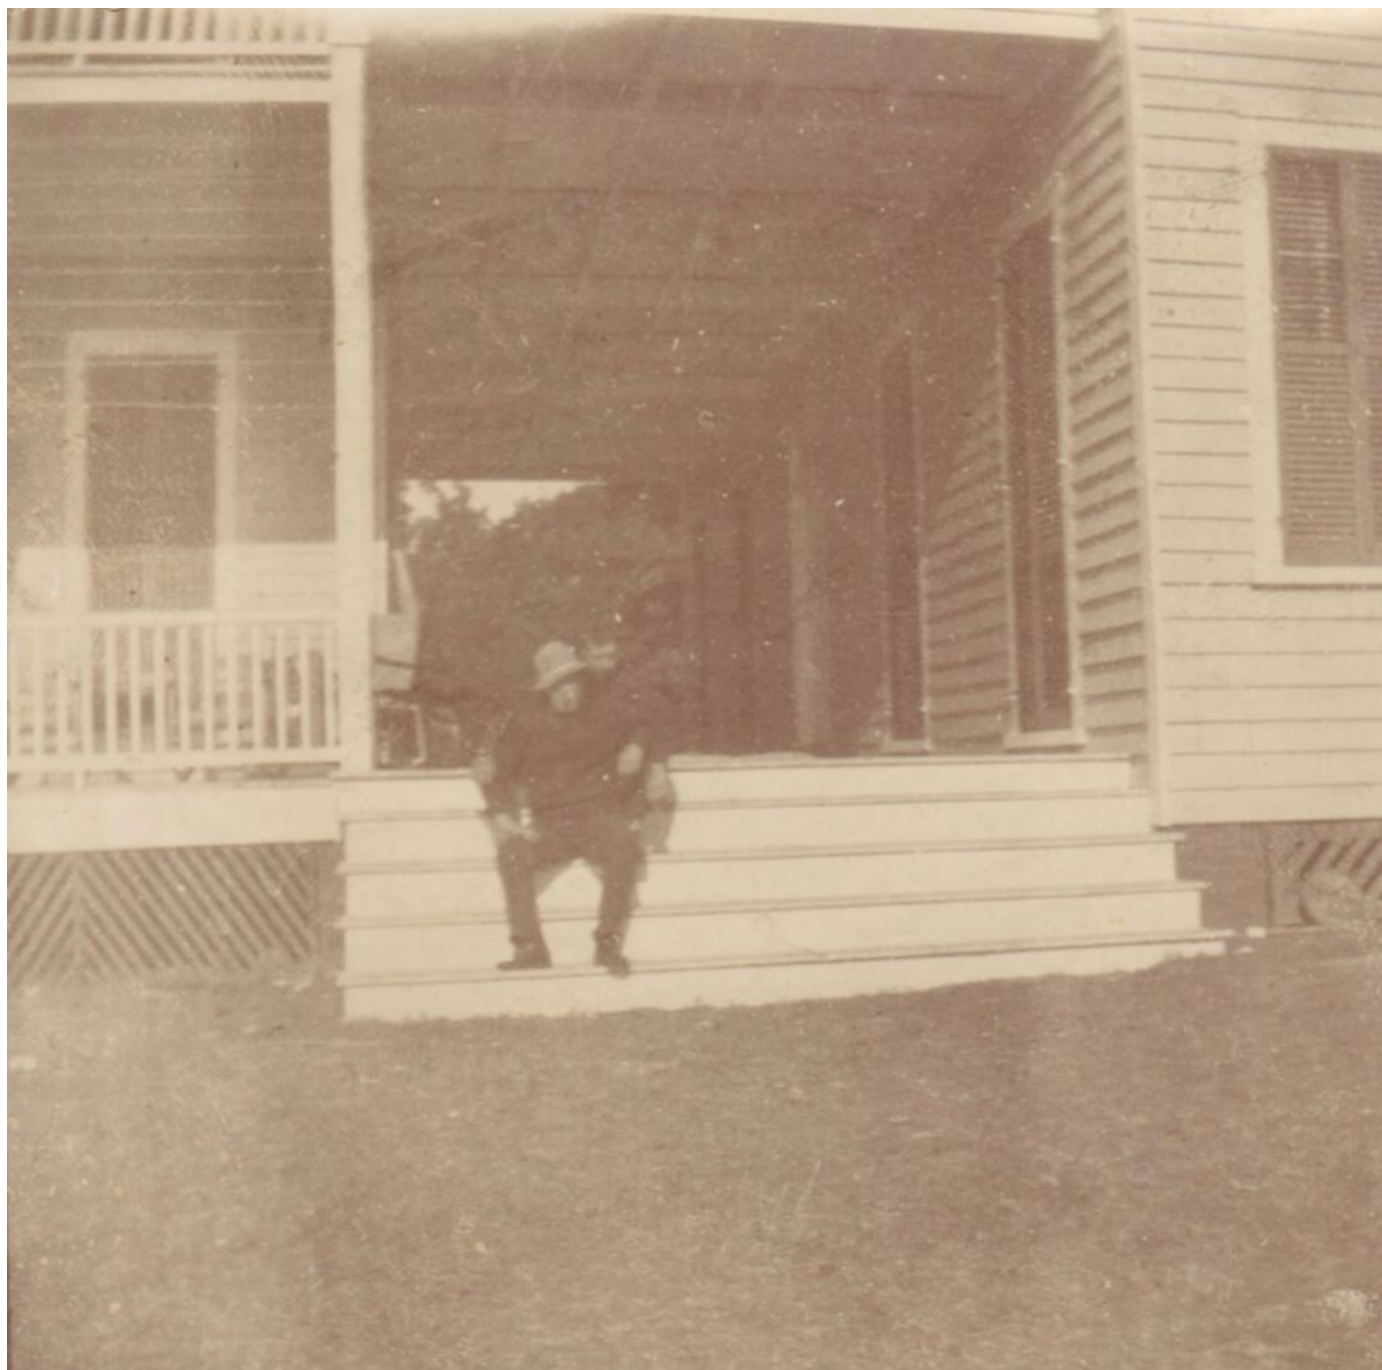
4. View of the dog-trot breezeway, pre-1937 alterations.

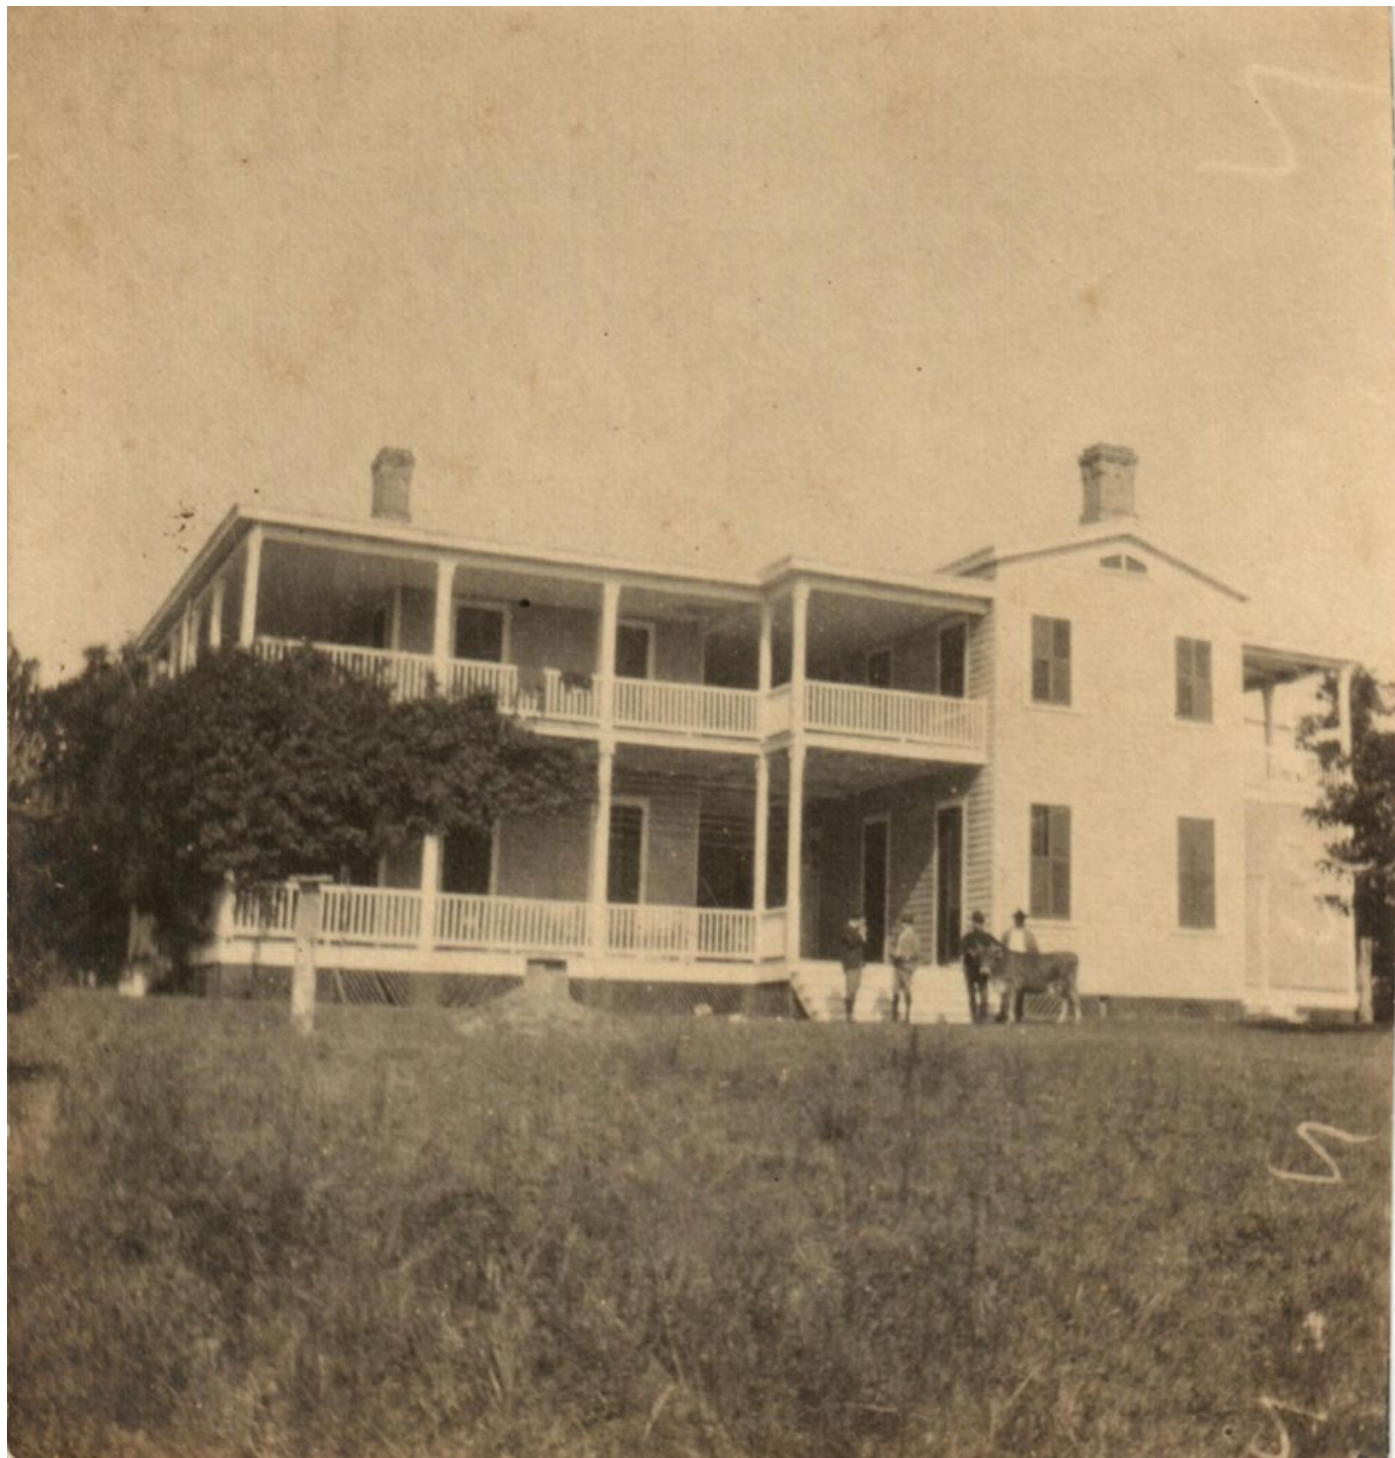
11. Sound side view of Halcyon Hall pre-1937 alterations.

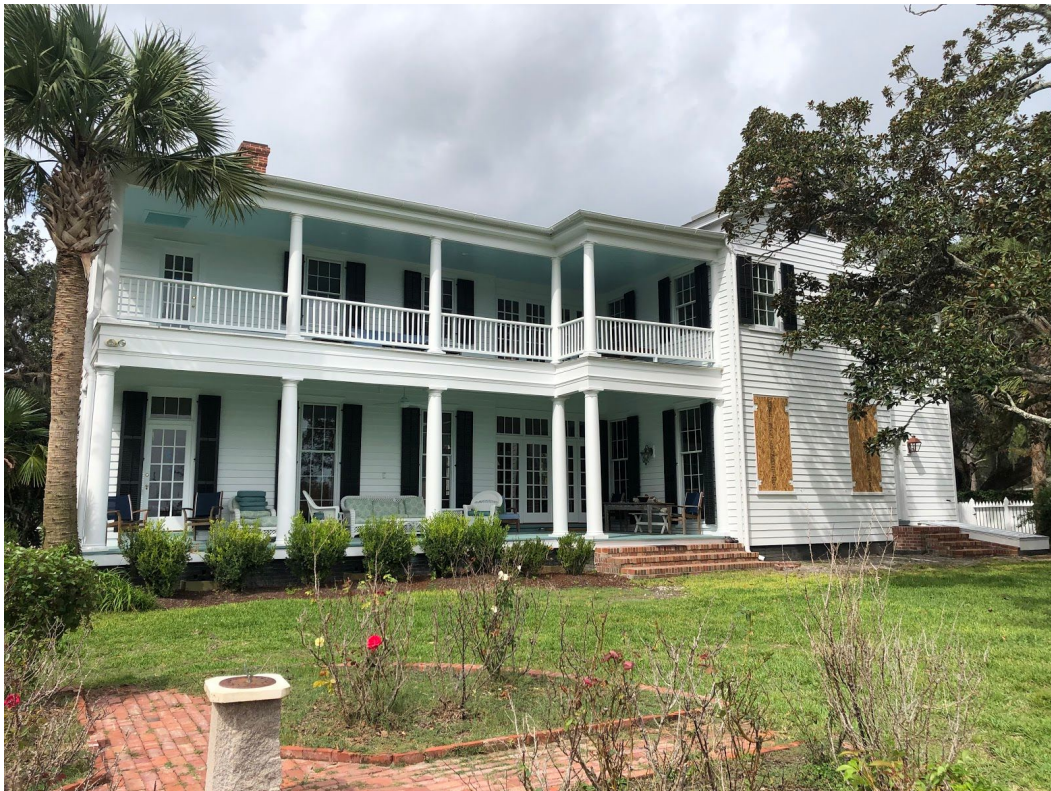
Fig. 4

- Fig. 4: Sound-Side (East) Elevation
- Fig. 5: Side (South) Elevation
- Fig. 6: Road-Side (West) Elevation
- Fig. 7: Side (North) Elevation
- Fig. 8-12: Exterior Features

The front, sound-side (east) elevation is seven bays wide (Fig. 4). There are three common bond brick corbeled chimneys, unpainted, on a low-pitched, asphalt shingle roof. The roof is hipped with a cross-gable forming the northern part of the “T” (Fig. 8). On the first level, the large, characteristic porches stretch south from the entrance doors to the south end of the home. On the first level, starting from the south side, the porch covers a 15-light single door with three-light transom, decorated with shutters to add symmetry with the windows on the first level. Next are two identical, floor-to-ceiling, six-over-nine sash windows, followed by the entrance doors. The 15-light entrance doors are flanked by 15-light sidelights, all with three-light transom windows. The windows allow for natural light to pour into the entrance hall and also provides lovely

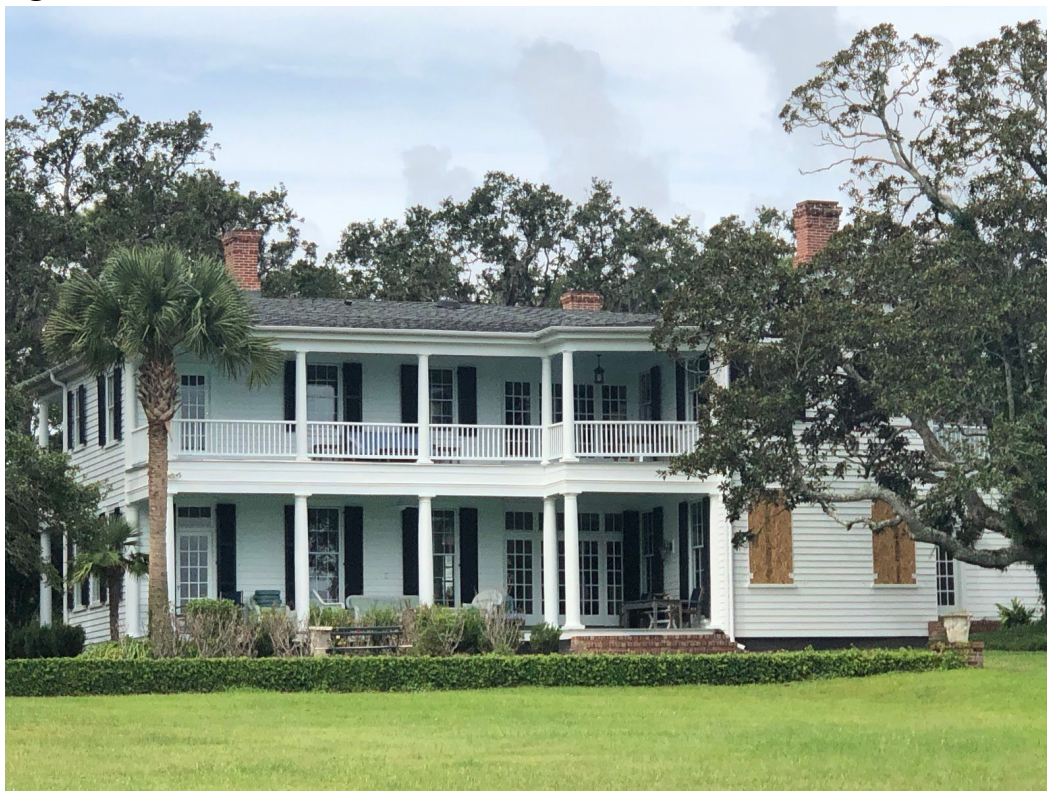
Fig. 8

- Fig. 8: Roof
 - Fig. 9: Chimney
 - Fig. 10: Siding
 - Fig. 11: Windows
 - a. First level windows
 - b. Second level windows
 - c. Sound-Side (east) elevation windows under porch

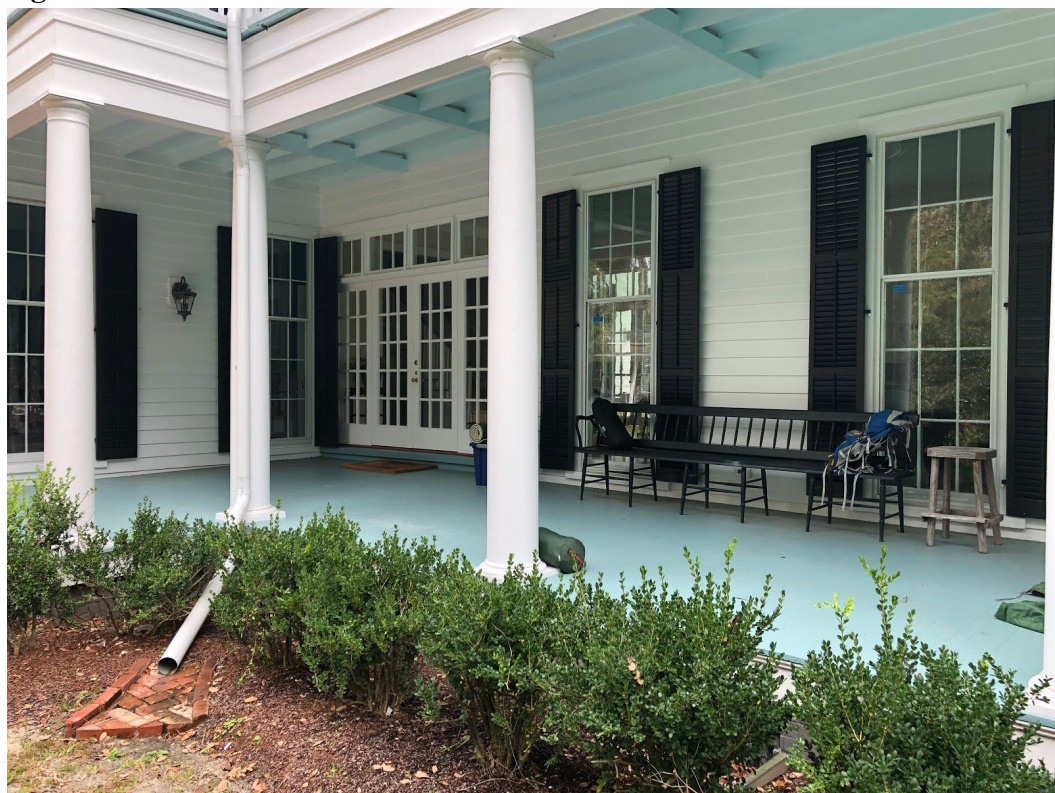
Fig. 11d

- d. Road-Side (west) elevation full-height windows under porch
 - Fig. 12: Doors
 - a. Sound-Side (east) door first level
 - b. Side (north) door first level

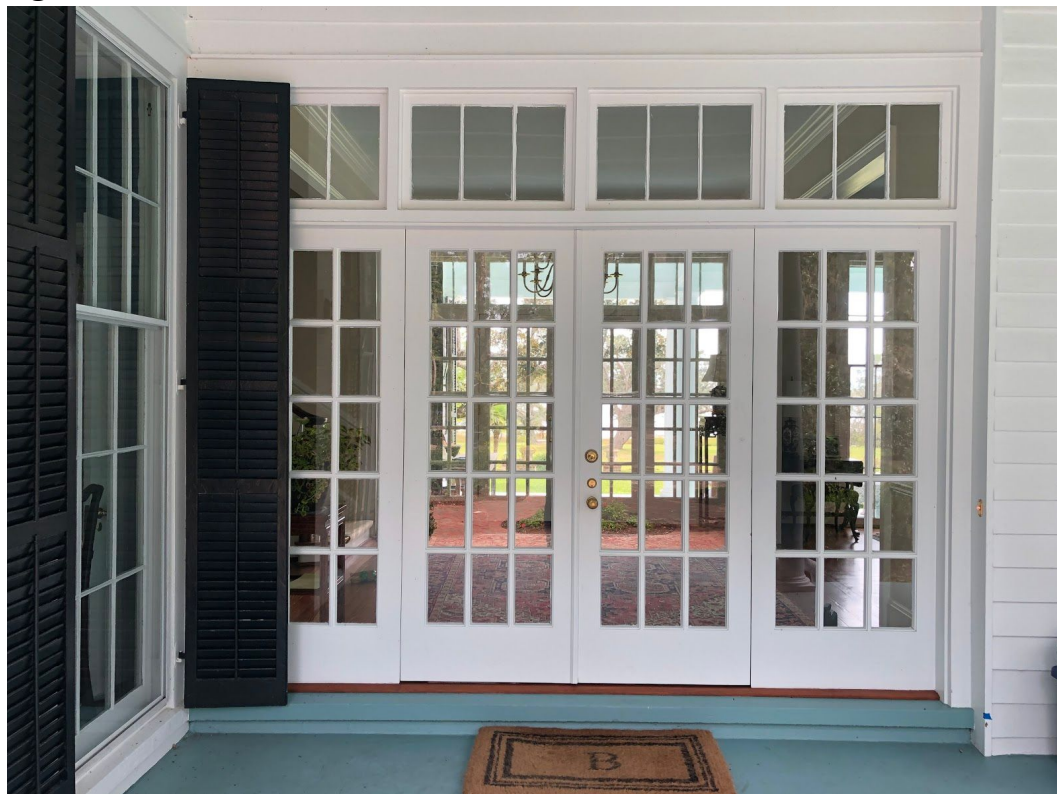
Fig. 12c

- c. Road-Side (west) door first level
 - d. Road-Side (west) doors first level
 - e. Road-Side (west) door second level
 - Fig. 13: Porches
 - a. Sound-side (east) porch first level

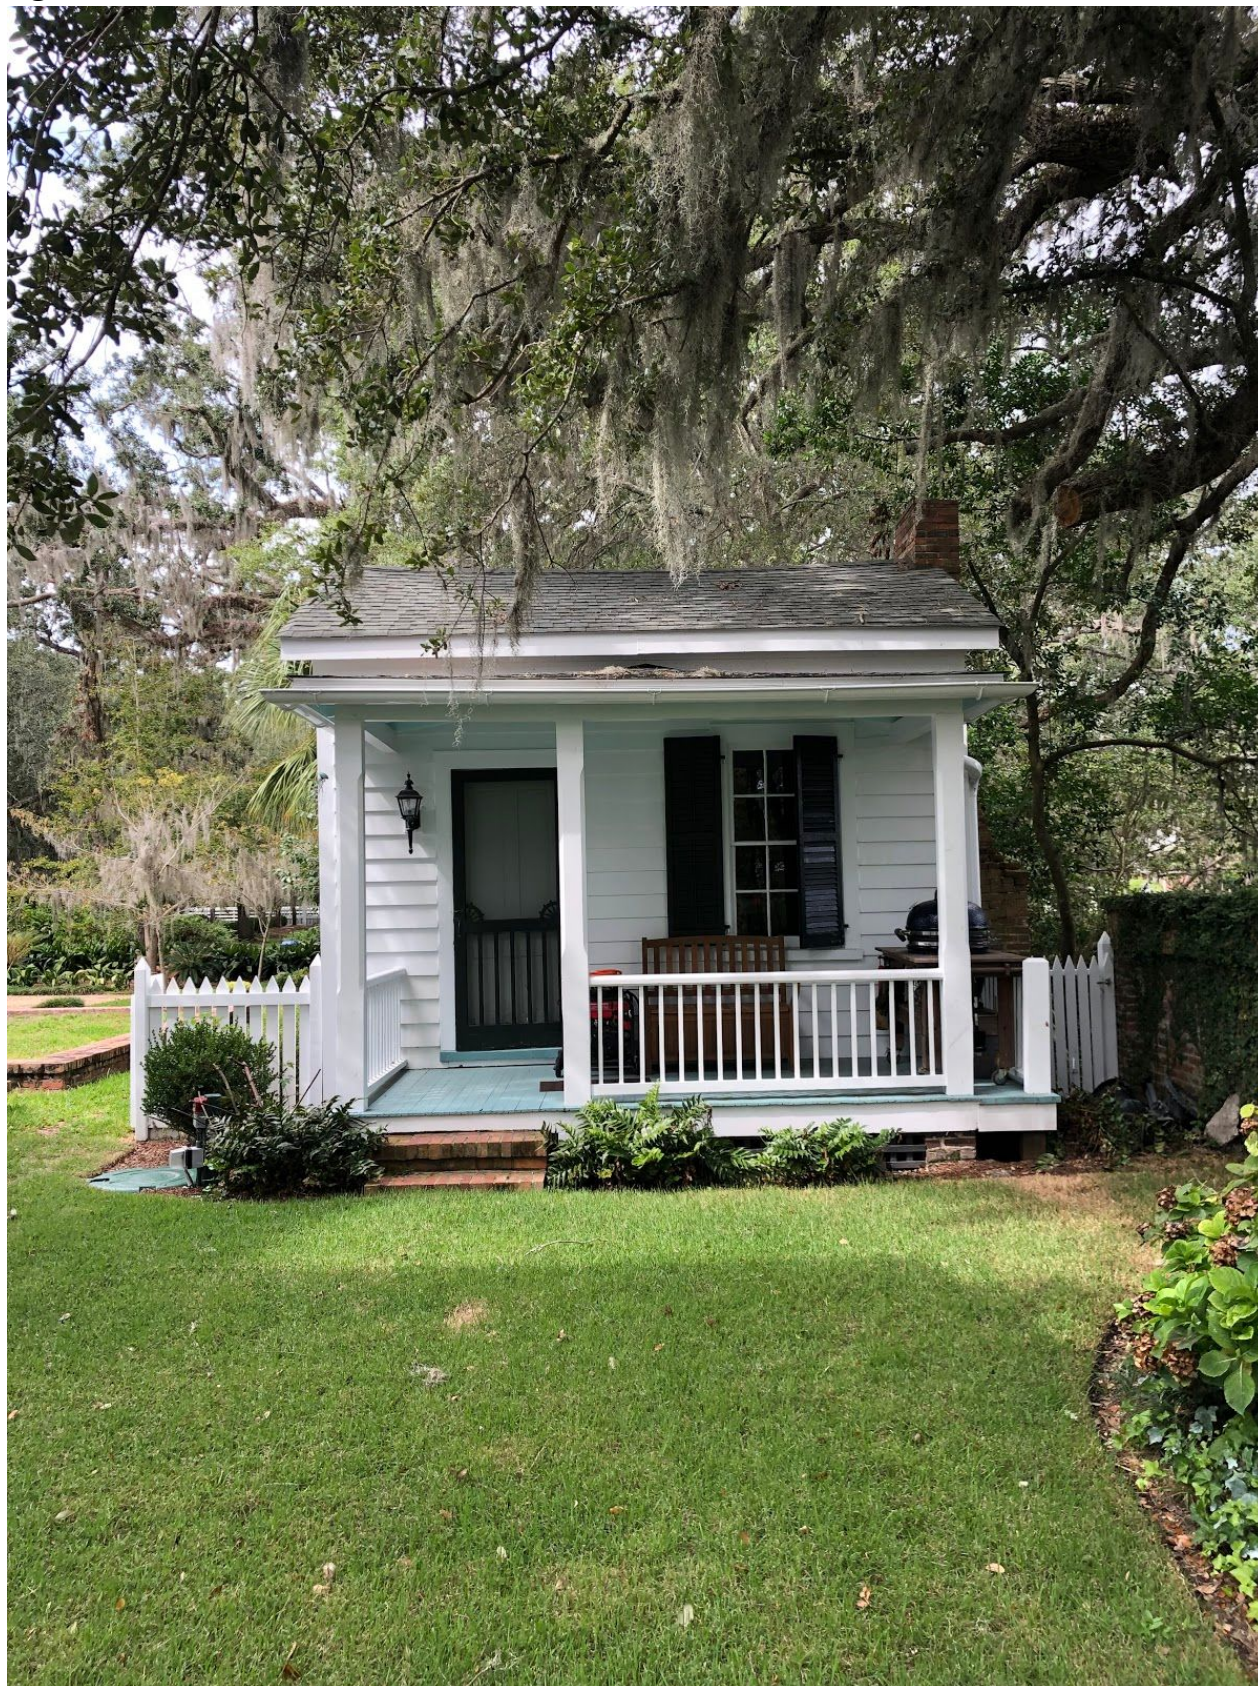
Fig. 14

- Fig. 14: Front (East) Elevation
 - Fig. 15: Side (South) Elevation
 - Fig. 16: Rear (West) Elevation
 - Fig. 17: Side (North) Elevation
- Fig. 18-21: Hunting Cabin

The servant's quarters is small, with a side-gabled, asphalt shingle roof and constructed of weatherboard siding, which matches the main house. The front (east) side of the side-gabled residence has a small front porch with original stick porch posts, covered by a shed-roof overhang (Fig. 14). The porch covers an original, wooden Victorian screen door, and a paneled front door with original, marbled rim lock hardware, and an eight-light window with black-green painted shutters. The front of the quarters faces the north side of the main house, which was where the service wing was located.²⁴

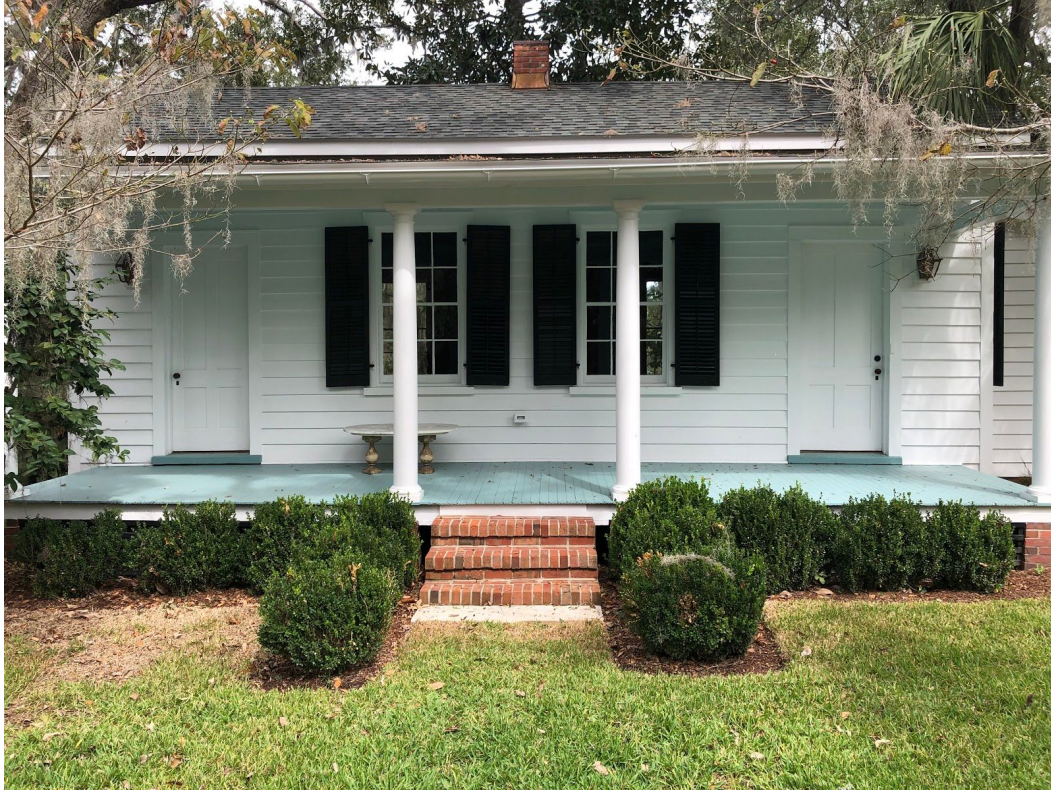
Fig. 18

- Fig. 18: Front (South) Elevation
 - Fig. 19: Side (West) Elevation
 - Fig. 20: Rear (North) Elevation
 - Fig. 21: Side (East) Elevation
- Fig. 22: Configuration of outbuildings

The front (south) elevation of the hunting cottage faces the road-approach to Halcyon Hall (Fig. 18). Starting from east to west, a shed-roof porch covers a paneled door, two identical six-over-six light windows with shutters, and a matching paneled door to the west side of the cottage. The side (west) elevation of the house shows the side gable and a six-over-six light window with wooden shutters (Fig. 19). The rear (north) elevation has two, six-over-six sash with no shutters (Fig. 20). The side (east) elevation has a six-over-six light window with shutters, and a small, shed-roof bathroom with a small six-over-six light window (Fig. 21).

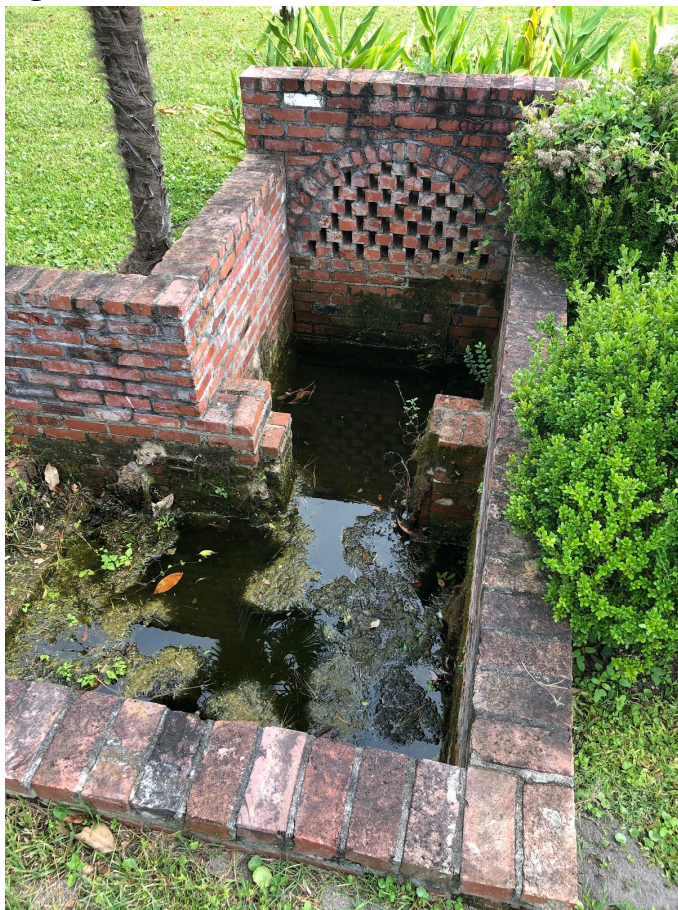
Fig. 23

- Fig. 23: Dairy Spring

Also present in the 1877 survey map is a dairy spring or springhouse (Fig. 23). The dairy spring was fed by rainwater and a natural, underground spring, which was dug out and reinforced with brick to be used for refrigeration. The spring water maintains a constant, cool temperature throughout the year and was used to keep meat, fruit, dairy products from spoiling. Historically, the structure was covered (Appendix 5).

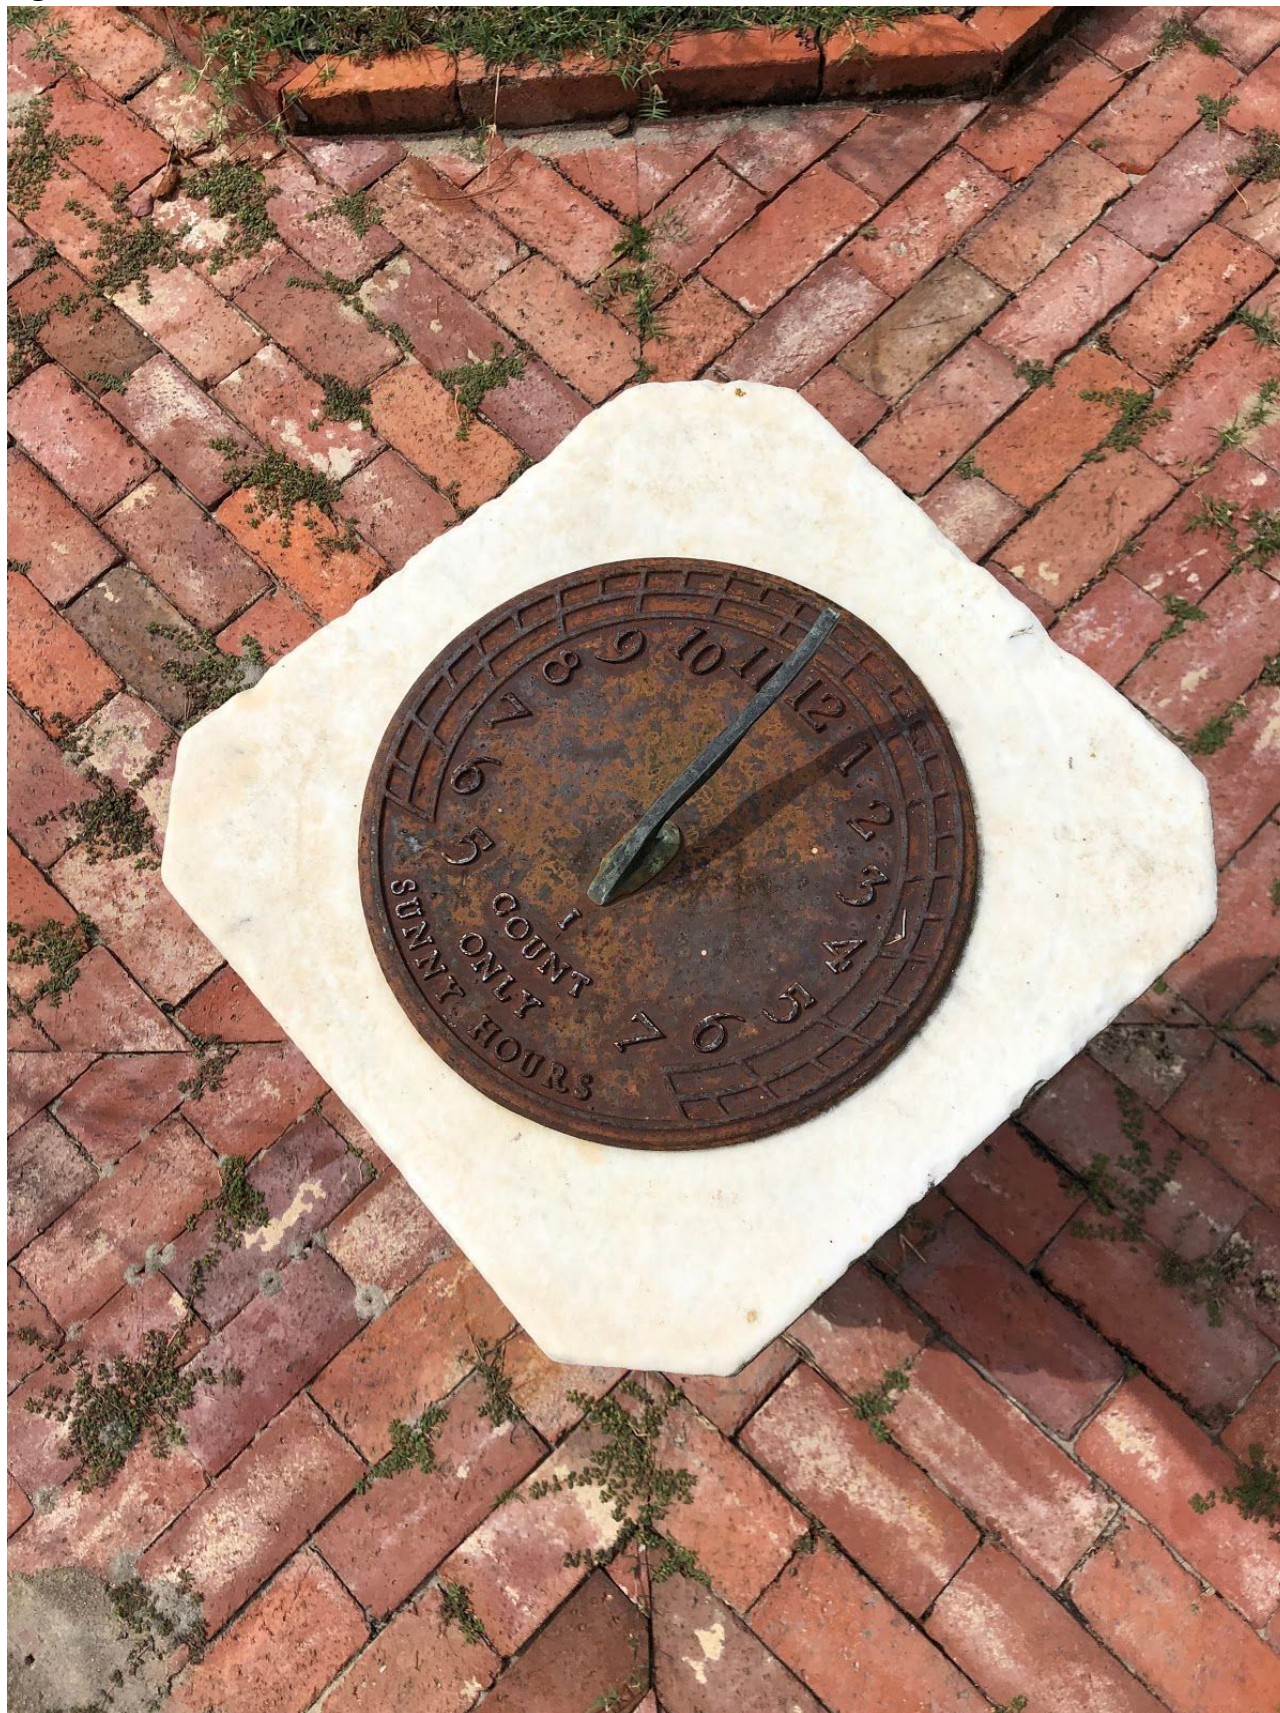
Fig. 24

- Fig. 24: Sundial

In the yard of the sound-side (east) elevation is a sundial, present since the 1877 survey map was drawn (Fig. 24). The sundial, also found in historic photographs, is in excellent condition. It is constructed of a granite pedestal with marble top. The clock itself is constructed of iron and copper. Along with the clock, the sundial reads, "I count only sunny hours." The humorous message enhances the significance of the home as a place for fun, relaxation, and recreation.
